# BRIDGES

## PRINCES HIGHWAY UPGRADE

### Bridge piles, Foxground to Berry Bypass

Broughton Pier piles

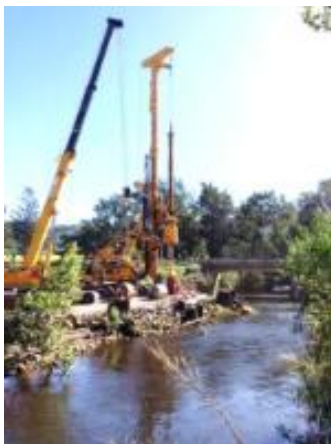
Environmental control at bridge site

Local creeks were used for water supply, with AFS ensuring environmental controls were used for keeping silt and concrete out of the creeks. Rock sockets were used with each pile to reduce steel quantity. Nearby contractors were employed to transfer, maintain and repair equipment.
